**SAS Superstructure**

Location: 04-SF-80-13.2 / 13.9

Daily Diary Report by Bid Item

Contract No.: 04-0120F4

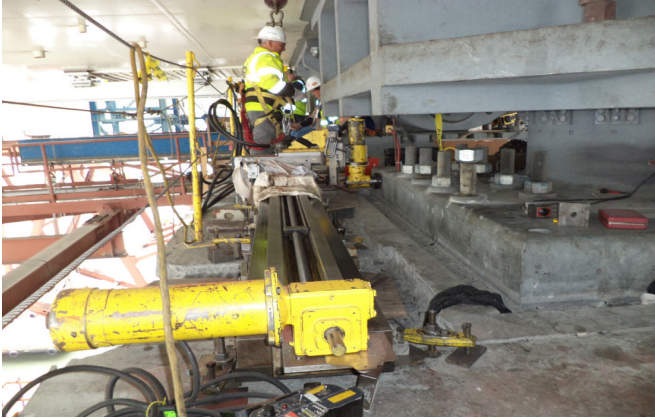
CCO 319 - In Place Machining (NPM) - 3 workers 12 hour shift
On site finishing set up machining equipment and started machining east side of E2W shear key base.

NPM informed me there is a difference of 3/8" from north to south on the east vertical surface. Confirmed with designers this shouldn't be a problem for saddle - west face with have 3/8" difference except from south to north of surface.

Maching Op E2W

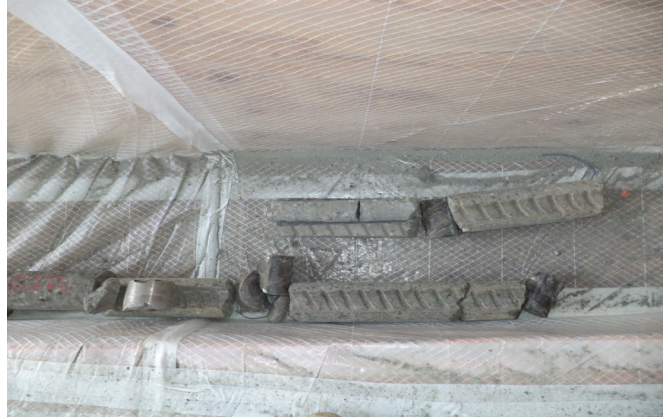
Penhal - CCO 326 - S. Calderon (LBRJRN) 8 Reg Hrs, 4 OT Hrs - Crew is coring at E2W additional core - Penhal is coring through a horizontal transverse #43 - core sections are being broken apart and removed removed in pieces because core is attached to #43 rebar. Penhal occasionally has to remove drill shaft from hole, core smaller hole to remove broken coring bits, concrete and #57 rebar that continuously get caught up in hole. Penhal is approximately 9.5 feet into cross beam.

Core Debris E2W

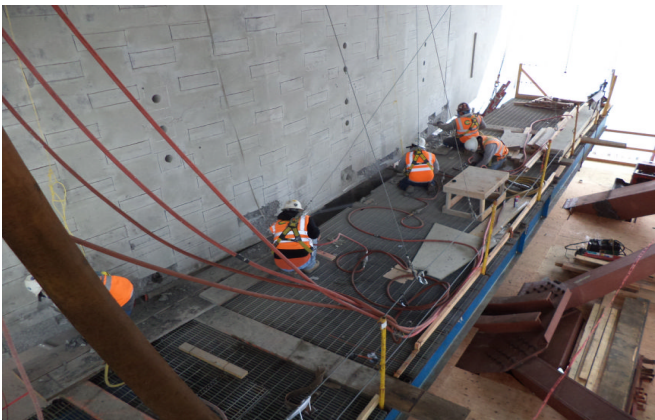
Laborers are chipping bushing concrete surface and key ways at E2E west face. Approximately 1/3 completed.

Chipping-Bushig Concrete E2E West Face

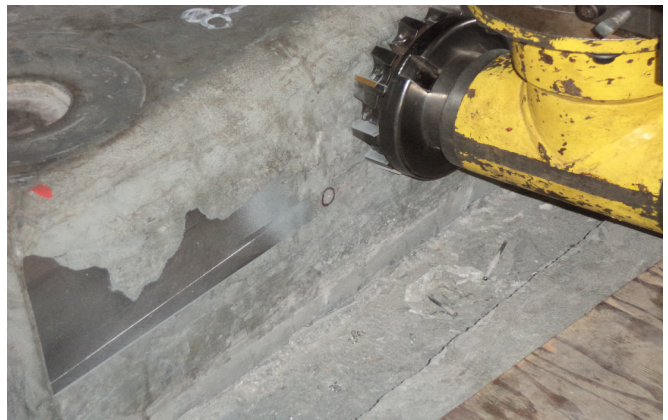
Maching Op E2W

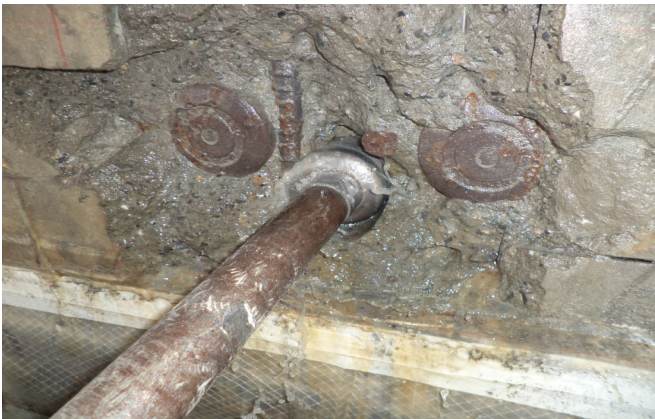
Coring Shaft E2W
